# Online Corrosion Monitoring Returns Plant to Continuous Operation after Two-year Corrosion Shutdown

A binary geothermal plant in Turkey experienced severe corrosion challenges due to the aggressive nature of the plant's brine. The corrosion led to damage in the plant's production wells and heat exchangers

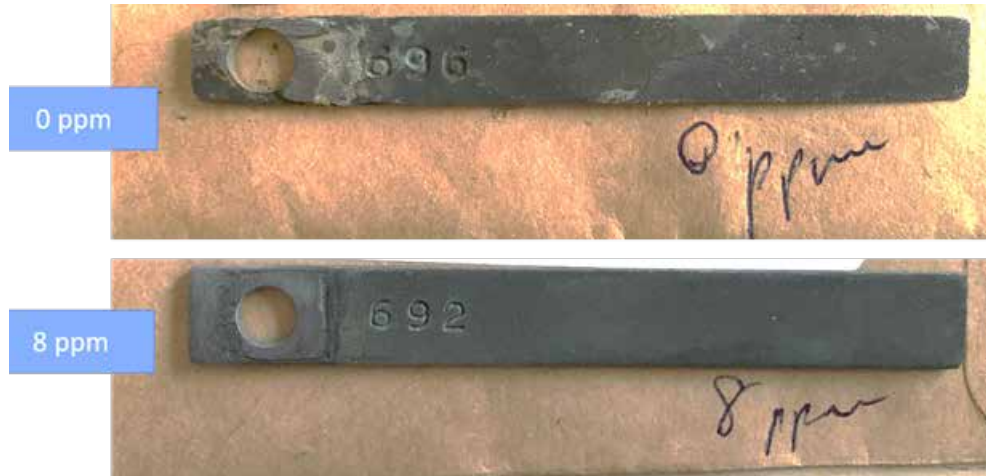
Figure 1: Corrosion coupon results comparing no treatment to GEO942 treatment after 7 days.

To ensure performance and dosage of GEO942 onsite, trials with traditional carbon steel coupons were performed. The test compared a pipeline with no treatment to a pipeline with GEO942 treatment. After seven days, the coupon without treatment already began melting, whereas the Nalco Water treatment reduced the corrosion rate by 793 mpy, an 88% improvement. The customer confirmed that these were the best results they'd ever seen at their plant and agreed to move forward with the program.

NALCO WATER CORROSION INHIBITOR TRIAL		Dosages	
		0 ppm	8 ppm
Putting the coupons and take off the coupons dates	5.02.2018	8,2180	8,1997
	12.02.2018	2,7227	7,5059
Coupon Mass Changes [mg]		5495	694
Corrosion Rate [mpy]		907,67	114,60

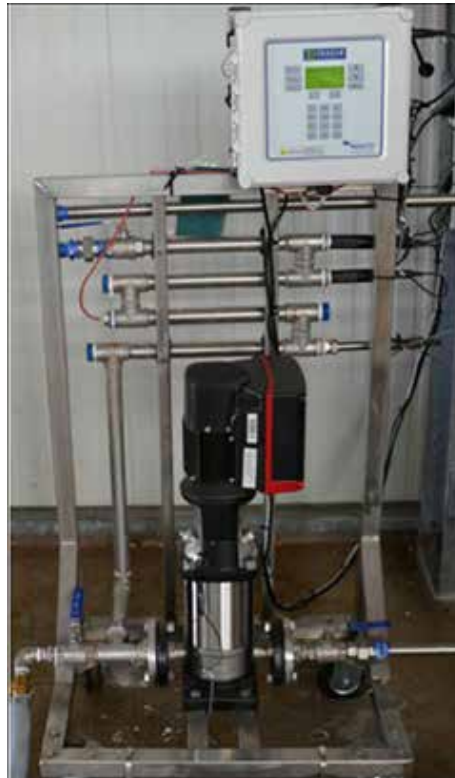
Figure 2: NCM skid for online corrosion monitoring.

The second component of the solution for this Turkish customer is the use of the online Nalco corrosion monitor (NCM) technology. This system enables real-time corrosion rate readings to ensure short-term action can be taken if any issues arise. The NCM technology is more highly advanced than traditional coupon readings, as the monitor adjusts the speed of brine flow, temperature, and pressure for every part of the probe. Figure 2 shows

the skid setup that displays changes immediately and enables enhanced protection for optimum results.

The customer has access to the NCM data 24/7 online from its website and if there is an extreme/sudden increase of the corrosion rate, the customer and the Nalco Water representative will be informed immediately via text message, e-mail and phone call from Nalco's System Assurance Center. The system is continually monitored and protected.
